CASE STUDY - GENERAL INDUSTRY - WASHING BARREL ROTARY COUPLING

Background

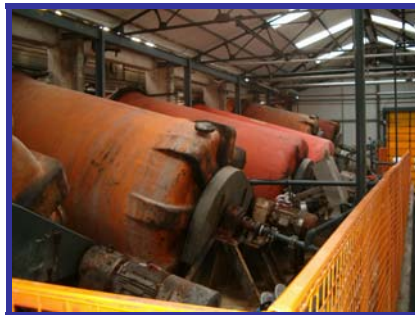
Animal hides are washed within rotary barrels in a caustic solution to remove contaminants prior to processing the leather. The barrels have a rotary hydraulic coupling fitted at the drive end, traditionally manufactured in steel and brass.

- Due to the highly corrosive environment the couplings had only a 1 year lifespan
- Seizure often occurred
- Significant cost of downtime to replace/maintain coupling

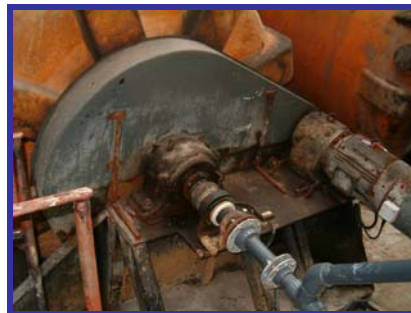
After careful evaluation of the application requirements, the couplings were replaced with a hybrid coupling consisting of Devlon S grade flanges, a Devlon T100 body and a PTFE inner.

- Coupling does not corrode
- Lifetime extended to in excess of 7 years
- Virtually eliminated downtime
