CASE STUDY - OFFSHORE INDUSTRY - THERMAL BARRIER

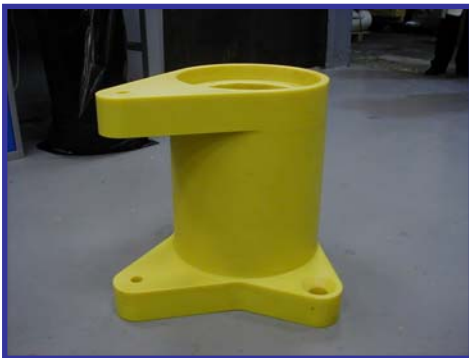
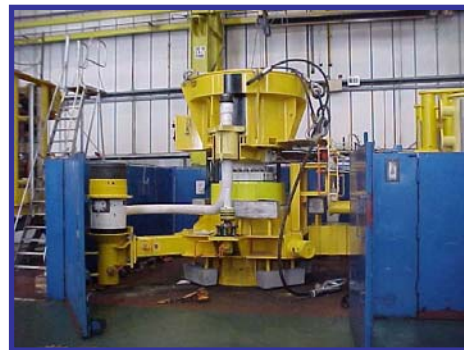
Devol developed a thermal barrier in our Devlon material which allows ROVs to dock into the wellhead to remove the flowspool without the needs to pull the tree completely.

- Slows down/prevents heat loss in the flowspool should the well be shut in for up to 12 hours
- Prevents hydrate formation and thus maintains flow when the well re-opens
- Eliminates the need to pull the tree to replace the flowspool, therefore giving major cost savings
- Lightweight and non-corrosive solution
- Cost effective solution for what could have been a major problem
